Little Apple Cars

Automobile Status Report

2015 Kia SOUL

VIN KNDJP3A52F7147979

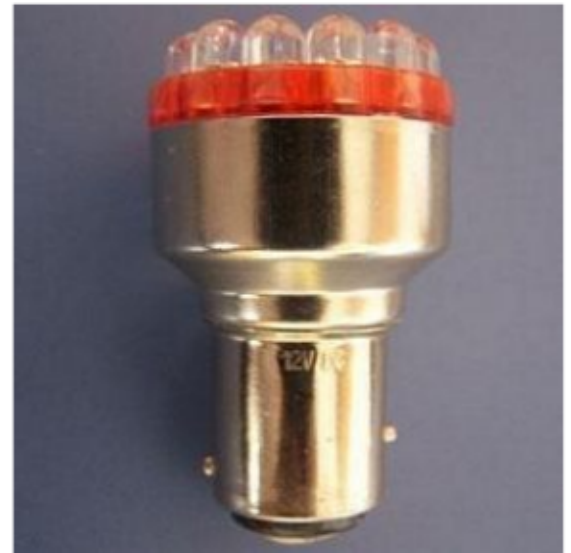
Back-up Light

Bulb - Back-up Light: Right

If not replaced, you will fail the vehicle inspection and could receive a ticket for improper equipment.

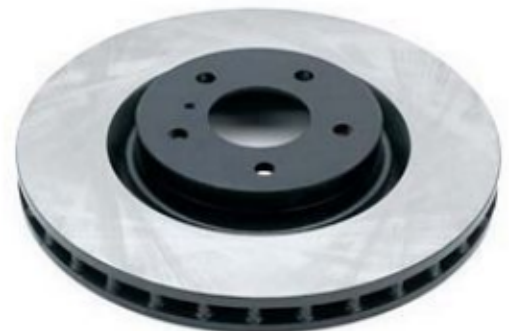
Brake Rotor Replacement - Front: Severe brake pulsation - rotors not resurface-able. Pads measure 8mm - inspect condition.

When the pads are replaced, the rotor must be resurfaced smooth to allow the new pads to have an even contact surface to work with. Only a small amount of material can be machined off of a rotor before it becomes unusable and must be replaced. A minimum thickness measurement is stamped on every rotor and the technician doing the brake job will measure the rotor before and after machining it to make sure it doesn't go below the legal minimum. If a rotor is cut below the minimum, it will not be able to handle the high heat that brakes normally generate. This will cause the brakes to "fade," greatly reducing their effectiveness to a point where you may not be able to stop. At this point the brake rotor needs to be replaced.

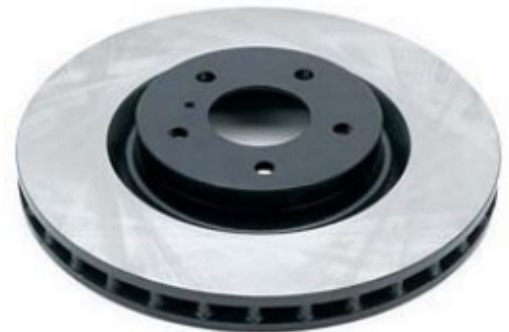
**Brake Rotor Replacement - Rear:
Severe brake pulsation - rotors not
resurface-able. Pads measure 7mm -
inspect condition.**

When the pads are replaced, the rotor must be resurfaced smooth to allow the new pads to have an even contact surface to work with. Only a small amount of material can be machined off of a rotor before it becomes unusable and must be replaced. A minimum thickness measurement is stamped on every rotor and the technician doing the brake job will measure the rotor before and after machining it to make sure it doesn't go below the legal minimum. If a rotor is cut below the minimum, it will not be able to handle the high heat that brakes normally generate. This will cause the brakes to "fade," greatly reducing their effectiveness to a point where you may not be able to stop. At this point the brake rotor needs to be replaced.

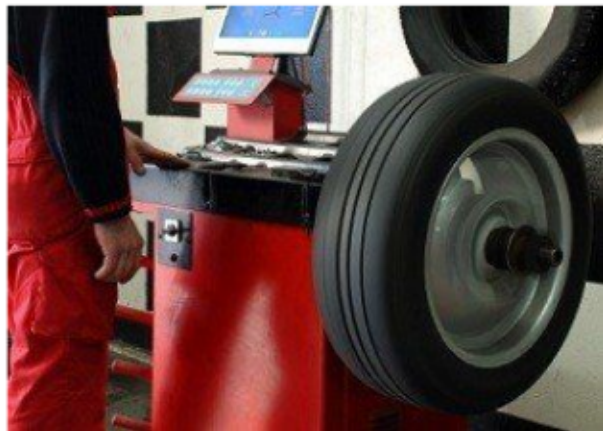
***Tire Balance and Rotate: Front 8/32,
Rear 10/32**

If not properly balanced, a vehicle's tires can experience abnormal wear which can significantly decrease the life of the tire. If not done, you will experience vibration in the steering wheel at certain highway speeds. Also, vibration will occur in the seat or floorboard at certain highway speeds. Tire wear will become scalloped or cupped.
