Automobile Status Report

2022 Honda ACCORD

VIN 1HGCV1F30NA060210

Multi-Point Inspection Checklist

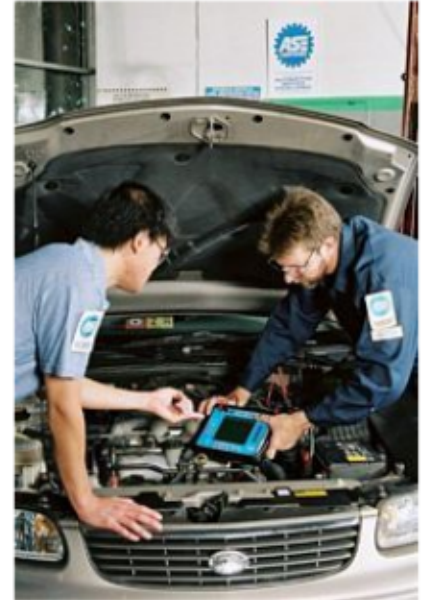
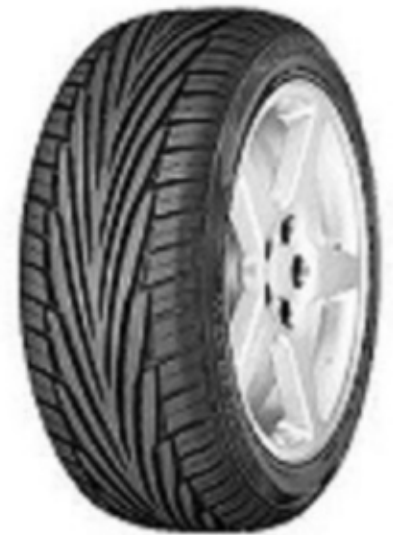
Tires

***Tires - 2: 235/40R19 - Left Front & Right Rear <5/32, 3/32. Move right front to right rear and place new on front.**

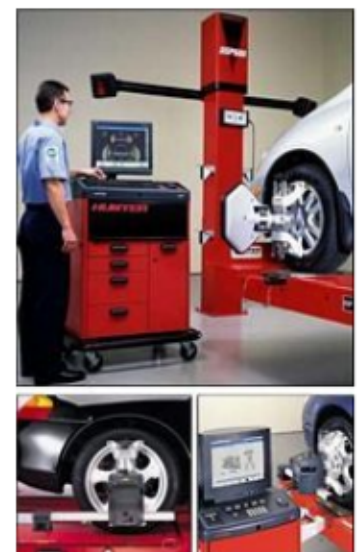
Alignment

*Alignment: Steering is off-center to the left.

If not done, you will see uneven or rapid tire wear, pulling or drifting away from a straight line, and wandering on a straight level road. It can also cause extra load on certain suspension components, making them more likely to fail.

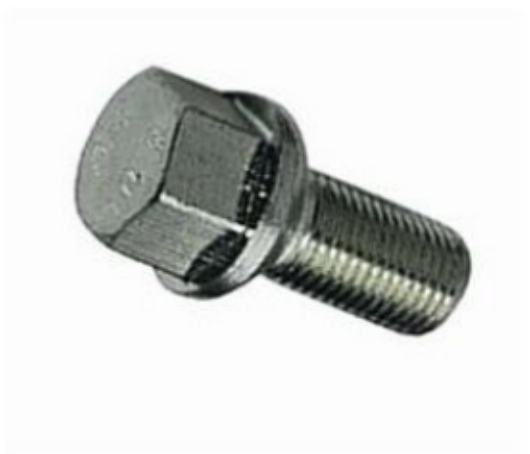
Wheel Fastener

Wheel Fastener: Six Black Acorn style lug nuts. Has some spline style lug nuts on all wheels.

If stripped, missing rusted or damaged in any way the wheel fasteners must be replaced. the wheel fasteners are the only objects holding your tire on your car. If left unfixed the wheel may become loose causing a major safety concern.

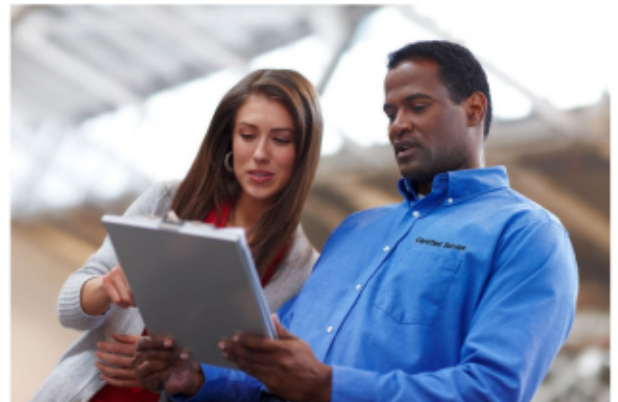
[Other]: Lug wrench is missing.

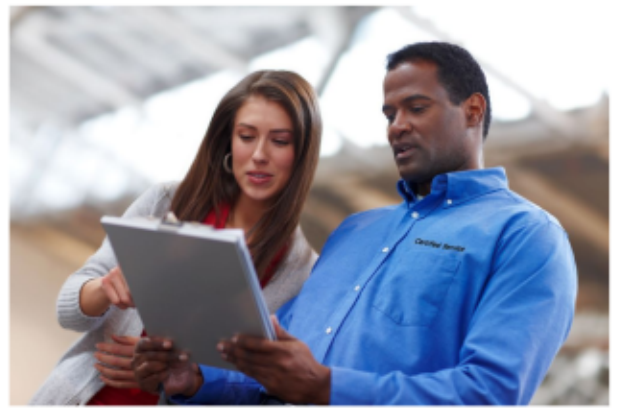
[Other]: Body damage to right front - sustained bumper and frame damage. Partly repaired. See notes.

PARTS	Qty	Description	Number	Price	Total
	1	WRENCH, WHEEL	89211S3VA11	\$15.82	\$15.82
				Parts and labor sub total	\$32.32
[Other]: Body damage to right front - sustained bumper and frame damage. Partly repaired. See notes. (I)					
LABOR	5.00 hours at \$165.00 per hour				\$825.00
PARTS	Qty	Description	Number	Price	Total
	1	FOGLIGHT, R. FR.	33900TLAA01	\$101.59	\$101.59
	1	FOGLIGHT, L. FR.	33950TLAA01	\$101.59	\$101.59
	1	MOTOR, WSWA	76806TVAA01	\$16.26	\$16.26
	1	GROMMET, WASHER TANK	76809TVAA01	\$6.70	\$6.70
	1	TANK, WASHER (2.5L)	76841TVAA01	\$39.45	\$39.45
	1	BUSH, WASHER TANK	76842SE4A02	\$3.27	\$3.27
	3	BOLT-WASHER (6X16)	934050601608	\$1.65	\$4.95
	1	STAY, R. INTERCOOLER	197016A0A00	\$10.66	\$10.66
	1	INTERCOOLER	197106A0A01	\$268.61	\$268.61
	1	GASKET, INTERCOOLER	197166A0A01	\$28.11	\$28.11
	1	CUSHION (LOWER)	74172TR0A00	\$4.29	\$4.29
	1	CVR, FR. BUMPER	71310TVAF00	\$43.35	\$43.35
	11	SCREW, TAP (5X14)	90113SJAA00	\$3.45	\$37.95

10	CLIP, BUMPER	91505TM8003	\$0.54	\$5.40
	1	HEADLIGHT ASSY., R.	33100TVAA42	\$1,198.66	\$1,198.66

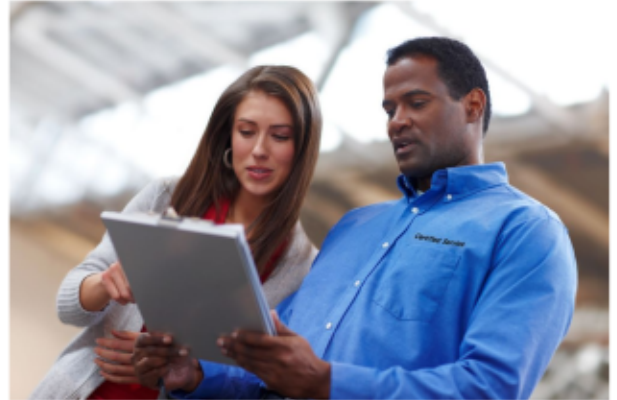
[Other]: Grease slung at right inner CV joint area from previous damage (New CV shaft installed). Clean during LOF.

[Other]: Grease slung at right inner CV joint area from previous damage (New CV shaft installed). Clean during LOF. (I)
