Automobile Status Report

2020 Toyota 4RUNNER

VIN JTEBU5JRXL5782995

Multi-Point Inspection Checklist

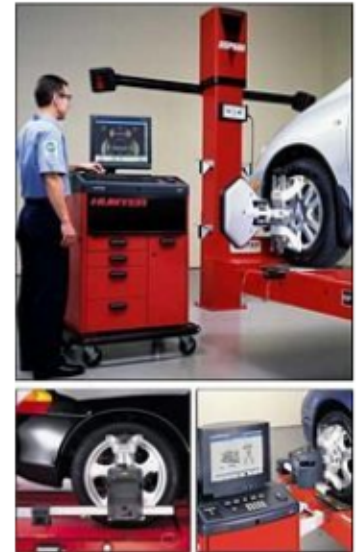
Alignment

*Alignment

If not done, you will see uneven or rapid tire wear, pulling or drifting away from a straight line, and wandering on a straight level road. It can also cause extra load on certain suspension components, making them more likely to fail.

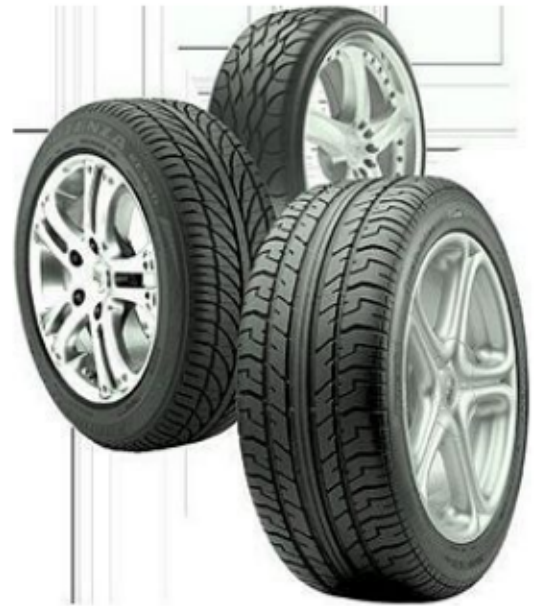
Tires

- LF 5
- RF 5
- LR 3
- RR 5

*Tires - 4: 265/70/r17

According to most states' laws, tires are legally worn out when they have worn down to 2/32" of remaining tread depth. As a tire wears it's important to realize that the tire's ability to perform in rain and snow will be reduced. With 2/32" of remaining tread depth, resistance to hydroplaning in the rain at highway speeds has been significantly reduced, and traction in snow has been virtually eliminated. If rain and wet roads are a concern, you should consider replacing your tires when they reach approximately 4/32" of remaining tread depth.

If snow-covered roads are a concern, you should consider replacing your tires when they reach approximately 6/32" of remaining tread depth to maintain good mobility. Because tread depth is such an important element for snow traction, winter tires usually start with noticeably deeper tread depths than typical All-Season or summer tires. Some winter tires even have a second series of "wear bars" molded in their tread pattern indicating approximately 6/32" remaining tread depth to warn you when your tires no longer meet the desired tread depth.

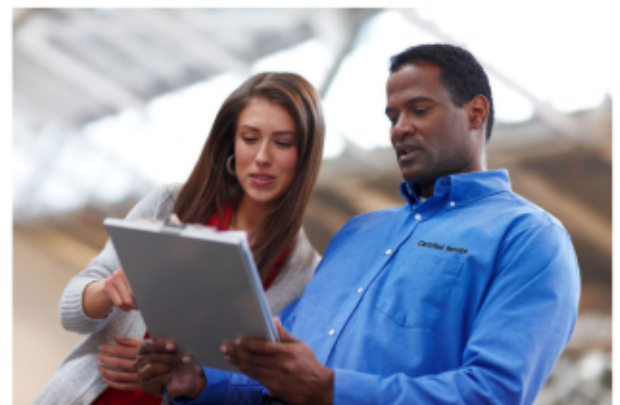
[Other]: 1 lug nut driver rear

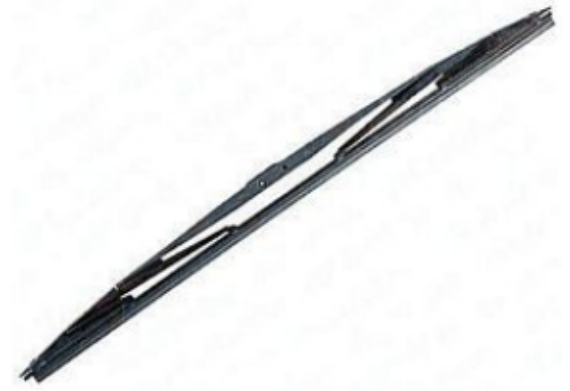
Windshield Wiper Blade

Wiper Blade Replacement - Front: front wipers are torn, INSERTS

If not replaced, worn out wiper blades can cause restricted visibility and permanent damage to the windshield.

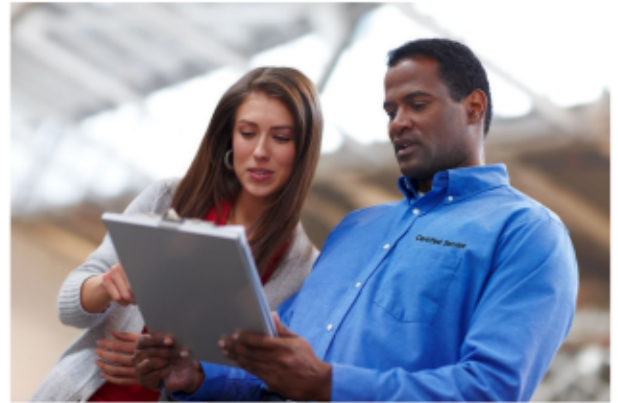
[Other]: tpms sensor driver rear missing

PARTS					
	Qty	Description	Number	Price	Total
	1	VALVE SUB-ASSY, TIRE	4260748010	\$102.36	\$102.36
Parts and labor sub total					\$234.36
