Automobile Status Report

2020 Ford ESCAPE

VIN 1FMCU9G6XLUA55340

Multi-Point Inspection Checklist

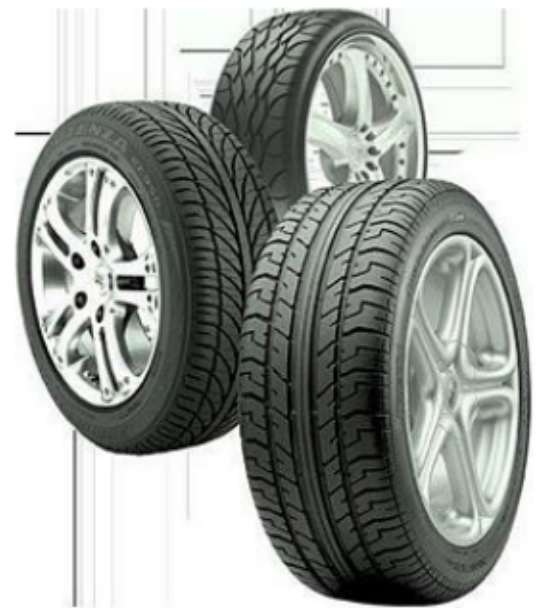
Tires

*Tires - 4: 225/65R17 - 4/32

According to most states' laws, tires are legally worn out when they have worn down to $\frac{2}{32}$ " of remaining tread depth. As a tire wears it's important to realize that the tire's ability to perform in rain and snow will be reduced. With $\frac{2}{32}$ " of remaining tread depth, resistance to hydroplaning in the rain at highway speeds has been significantly reduced, and traction in snow has been virtually eliminated. If rain and wet roads are a concern, you should consider replacing your tires when they reach approximately $\frac{4}{32}$ " of remaining tread depth.

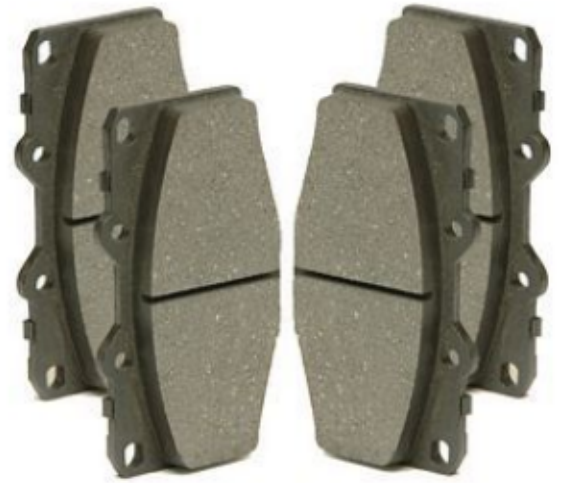
Brake Pads Replacement Only - Rear: 4mm

Brake pad material wears out over time. Brake pads should be periodically inspected for wear, which is highly variable depending on vehicle weight and driver habits. Brake pads must be replaced before the friction material is worn away completely. If it isn't, metal-to-metal contact will occur between the brake rotor and the worn-out brake pad. If metal-to-metal contact occurs, the brake rotor will be damaged, and it will need to be resurfaced or replaced.

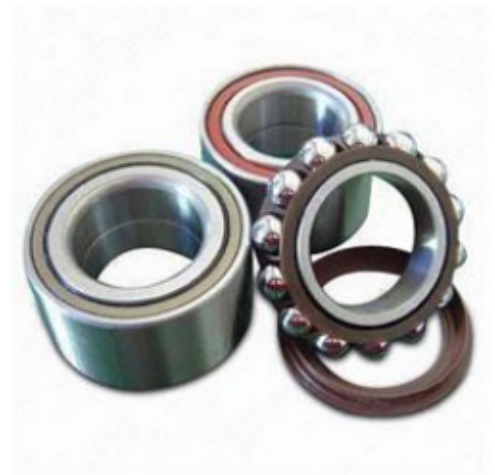
Wheel Bearing Replacement - Rear: PASSENGER REAR WHEEL BEARING NEEDS REPLACED

If not replaced, you will experience premature tire wear and suspension damage.
